Subject: Bridge Street bridge site visit

The Watershed Management Division (WSMD) conducted a site visit to the Royalton Bridge site visit on 7/12/2018 in response to reports of a substance dripping on recreationalists (i.e., swimmers and tubers). Site visit was conducted by Rick Levey, an Environmental Scientist with the Watershed Management Division.

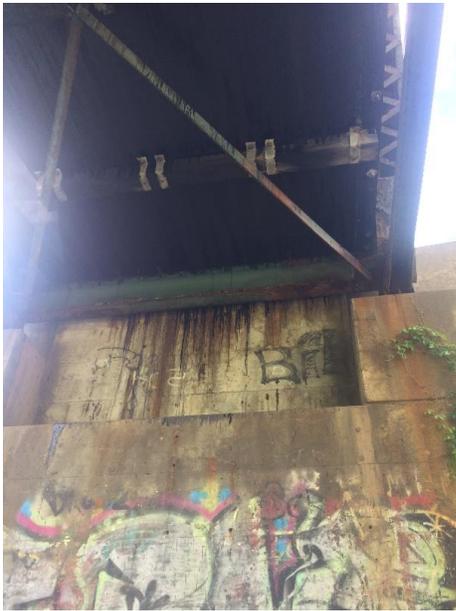
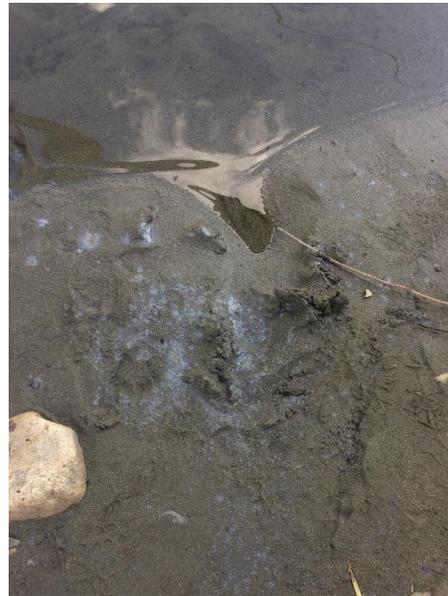
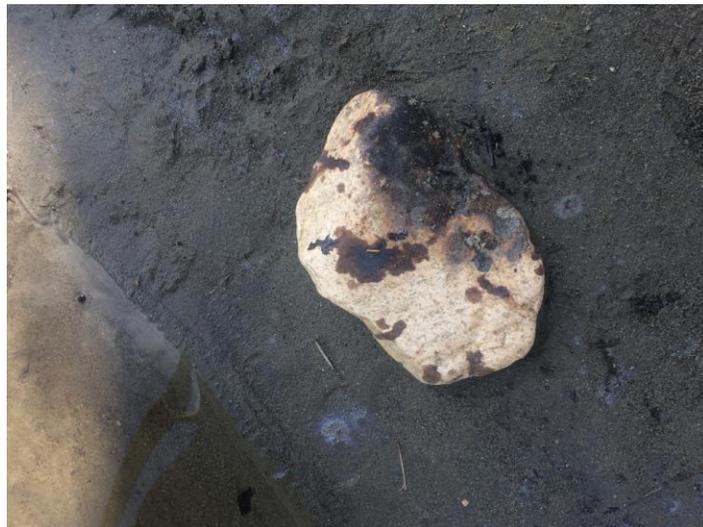
- Evidence of significant weeping/dripping on concrete abutments on both sides of bridge.
- Evidence of weeping on underside of bridge wooden deck (between wood).
- Evidence of creosote drippings on "dry" rocks below bridge.
- Evidence of creosote drippings on "dry" sand / substrate below the bridge.

Photos showing the apparent creosote dripping, and substrate below the bridge with creosote:

1. **Signage should be installed** at this bridge site informing all users that there is “Risk of Creosote Exposure,” especially under the bridge during hot weather periods and immediately downstream of the bridge. **Signage should be apparent** to river users traveling by boat and/or tube.
2. Develop corrective action plan and/or mitigation to prevent “creosote weeping” from entering river corridor and public use area. A variety of mitigation actions could be considered, the degree of which will directly inform the depth of engineering and potential remediation actions.
